文件名称	Modem 简单流程及案例分析 V1.0		
文件编号		版本编号	V1.0
发布日期	2015-11-27	主控部门	软件二部

### （二） 2G/3G Register

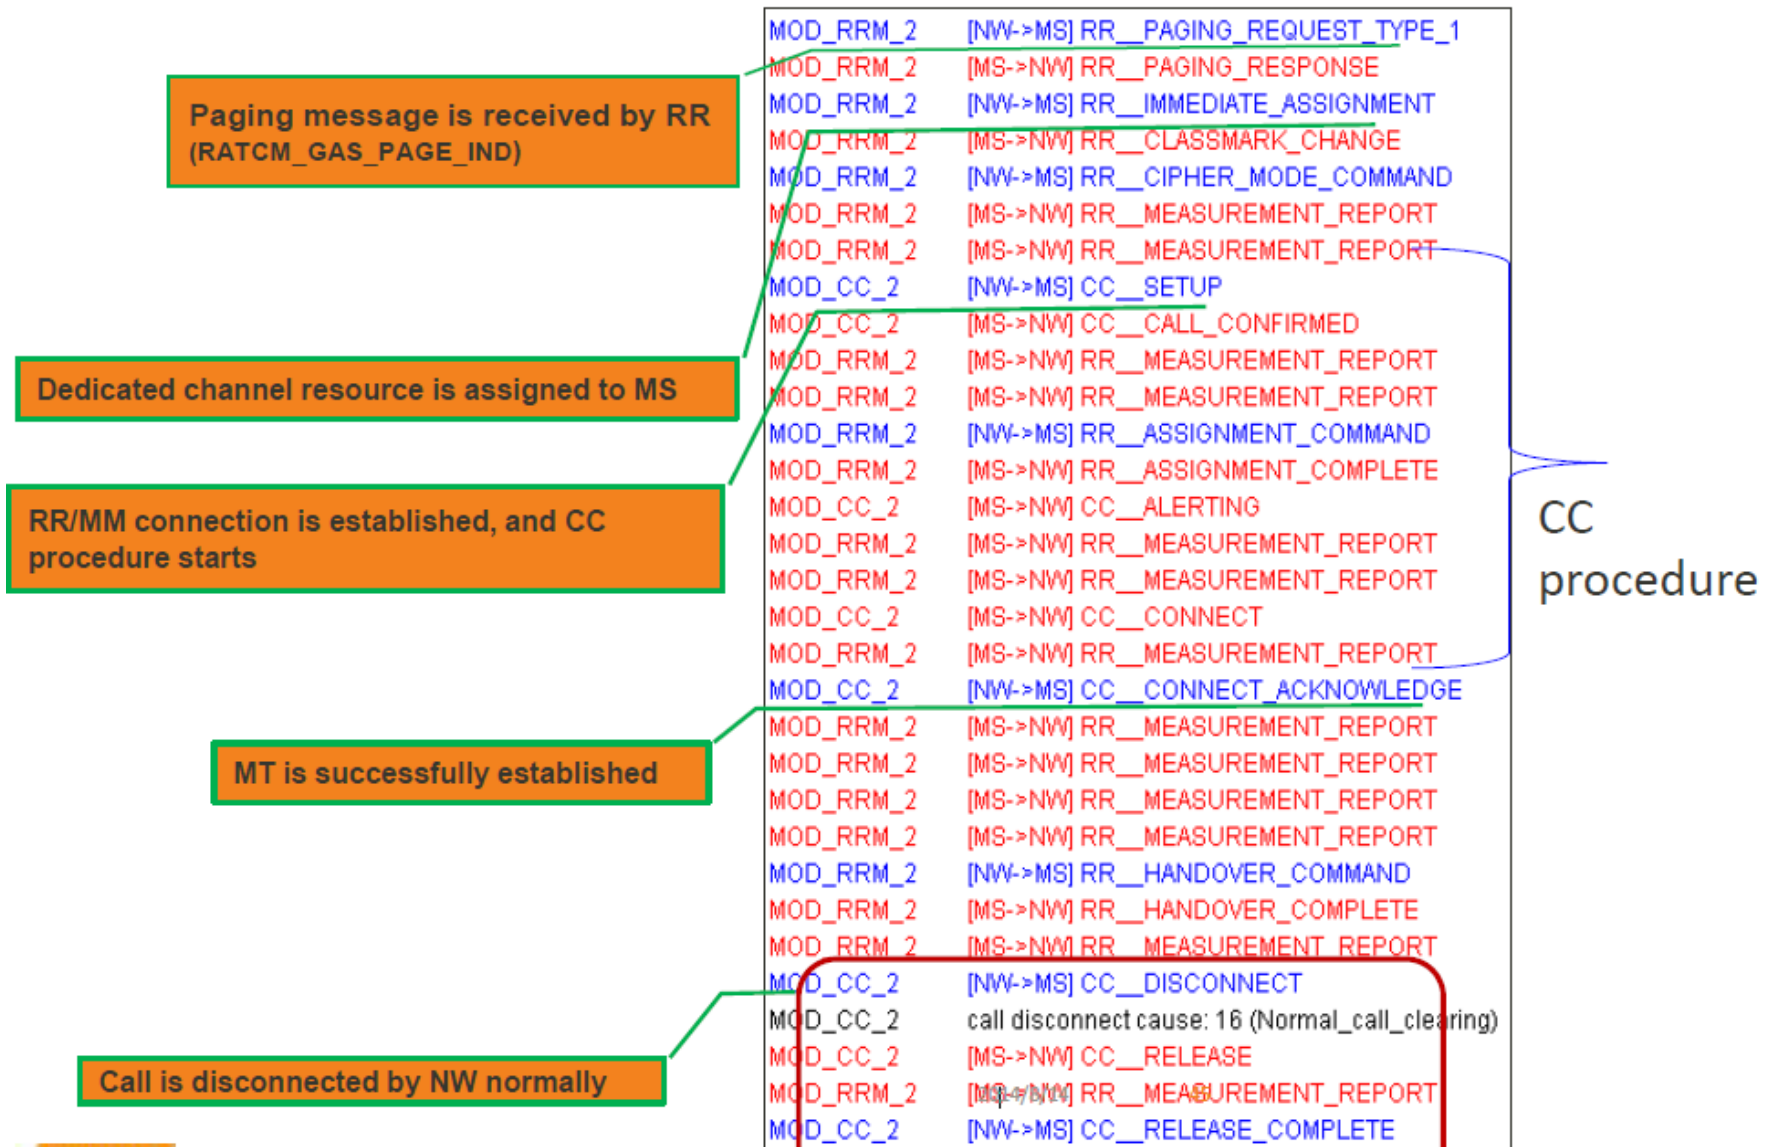
### (一) 2G MT call

大致被叫流程:

MOD\_RRM, , TRACE\_PEER, [MS->NW] RR\_PAGING\_RESPONSE 手机相应网络寻呼  
 MOD\_RRM, , TRACE\_PEER, [MS->NW] RR\_CHANNEL\_REQUEST 2G频道请求  
 MOD\_CC, , TRACE\_PEER, [NW->MS] CC\_SETUP 呼叫建立  
 MOD\_CC, , TRACE\_PEER, [MS->NW] CC\_CALL\_CONFIRMED 手机确认呼叫  
 MOD\_CC, , TRACE\_PEER, [MS->NW] CC\_ALERTING 手机发信号  
 MOD\_CC, , TRACE\_PEER, [MS->NW] CC\_CONNECT 手机建立通话  
 MOD\_CC, , TRACE\_PEER, [NW->MS] CC\_CONNECT\_ACKNOWLEDGE 网络应答  
 MOD\_CC, , TRACE\_PEER, [MS->NW] CC\_DISCONNECT 手机断开  
 MOD\_CC, , TRACE\_PEER, [NW->MS] CC\_RELEASE 网络释放  
 MOD\_CC, , TRACE\_PEER, [MS->NW] CC\_RELEASE\_COMPLETE 手机彻底释放  
 MOD\_RRM, , TRACE\_PEER, [NW->MS] RR\_CHANNEL\_RELEASE 2G频段释放通话

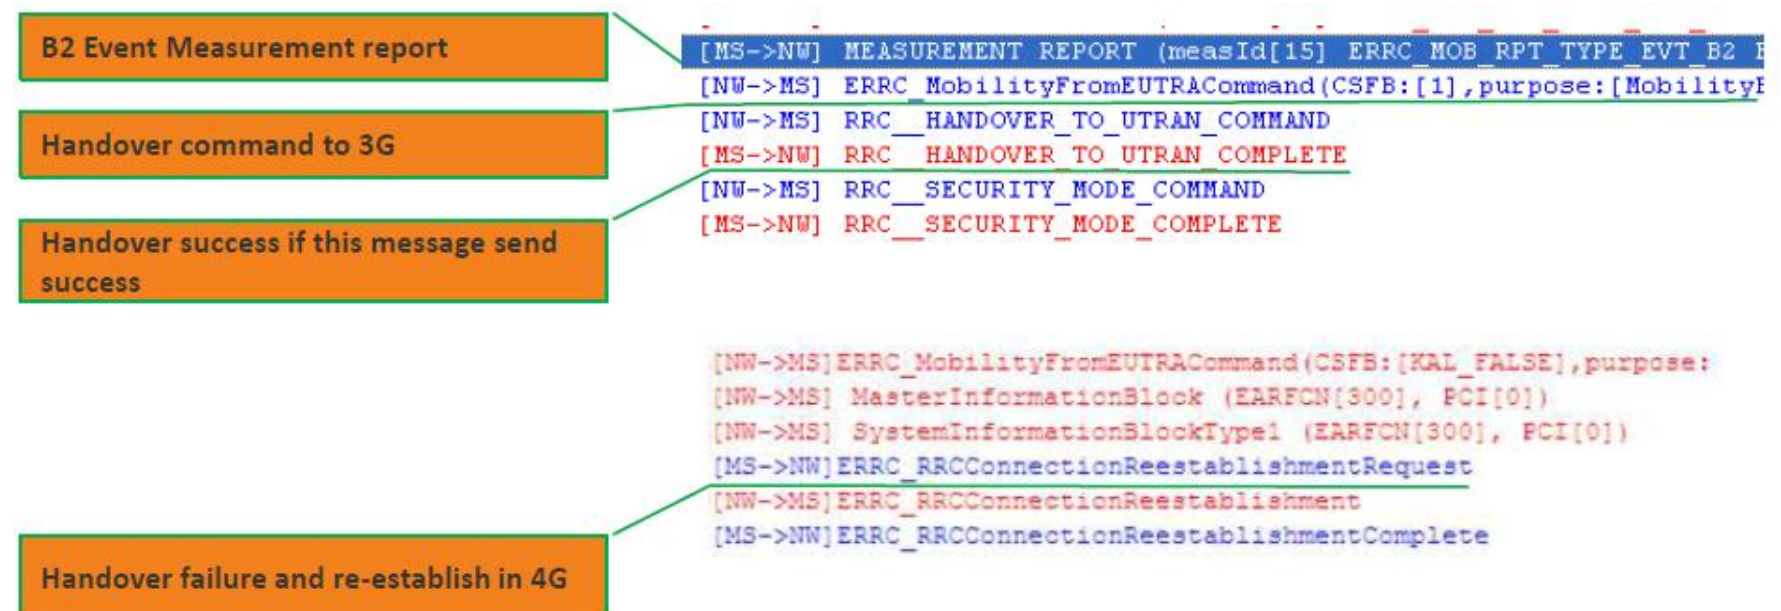
d. Step 4: Handover command

搜索 “ERRC\_MobilityFromEUTRACommand”
